ALIPLAST sp. Z o.o. TEST REPORT

Air Leakage, Water Penetration Resistance & Uniform Load

MS Wall - Fixed Window Wall Combination - Mulled

103682459COQ-001H

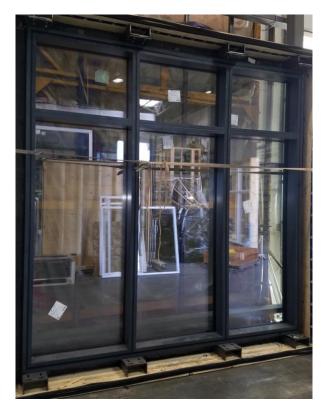
MS Wall - Mulled façade window wall system - Interior

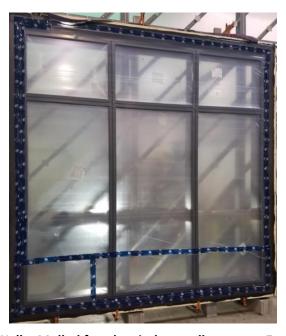
MS Wall – Mulled façade window wall system – Exterior

*Note – Picture taken with poly in place during the air leakage test

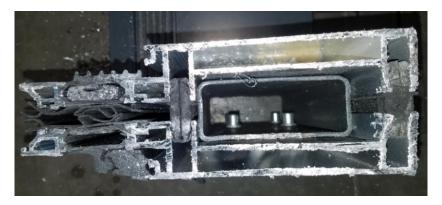
Jamb assembly

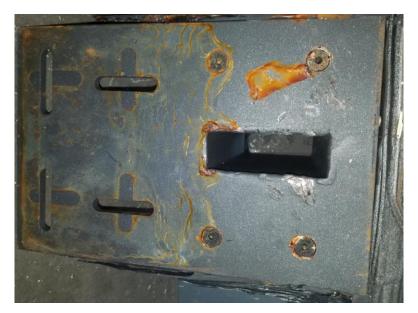
Installation plate for mullion

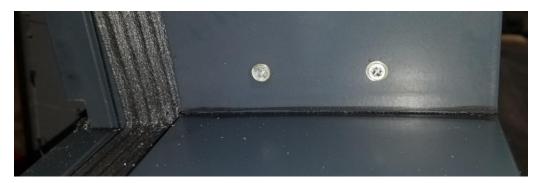
Screws for the horizontal mullion in to shear block

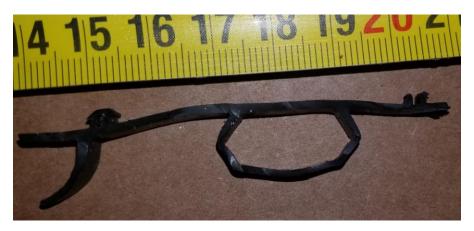
Interior side frame and sub frame gasket for the jambs

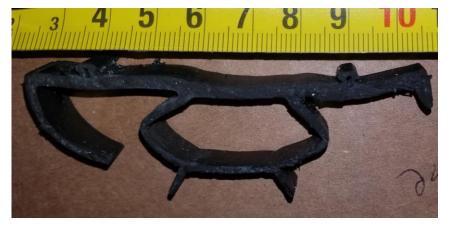
Interior side frame gasket for the sill

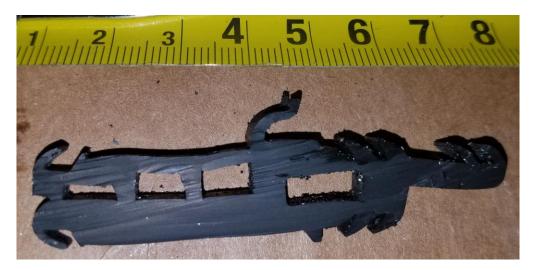
Gasket joining the main frame and sub frame profiles for the sill.

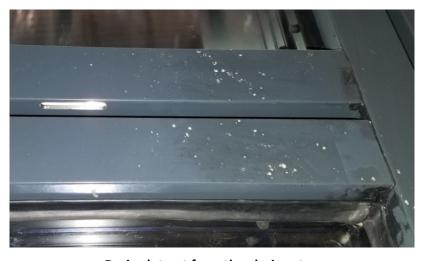
Drain slot out from the glazing stop

Fixed Window (6x)
Sub-Frame	 Material: Thermally broken aluminum Reinforcement: None. Corners: Aluminum corner key is used in the large frame cavity. The thermal strut cavity was filled with a foam profile.
Drainage	 The horizontal glazing stops at the bottom of each glazing unit have 30 mm (1.18") x 5 mm (0.20") slots to provide drainage. 2x slots, each centered approximately 130 mm (5-1/8") from the end of the stops. The 2x main frame gaskets along the sill each have 2x notches to allow drainage, each approximately 25 mm (1") wide. The exterior gasket is centered approximately 152 mm (6") from the corners, and the gasket behind the exterior layer was centered approximately 305 mm (12") from the corners.
Glazing (5x)	 IGU specification: 4 mm annealed / 4 mm annealed / 6 mm tempered with 2x 16 mm Warm-Edge Spacers (Chromatech Ultra, Black 9004), sealed together using Hot melt butyl. Overall thickness, 46 mm (~1.8") Glazing Blocks: 2x aluminum angle profile setting block carriers are adhered to the sill or horizontal mullion, centered approximately 178 mm (7") – 229 mm (9") from the edge of glass. Each aluminum setting block carrier had a plastic setting block set on it, approximately 102 mm (4") x 32 mm (1-1/4") x 1 mm (0.04"). Laid-in, exterior glazed on top of glazing gaskets, applied as 4 strips with the corners sealed with silicone. A foam profile is used around the entire perimeter of each sealed unit, adhered to the thermal strut, continuous around the corners but not at the setting block locations. Glazing Stops: Aluminum glazing stop is continuous as 1 piece along the verticals for the bottom and top windows. The horizontal are mitred to the verticals at the top of the top unit, and bottom of the bottom unit, the glazing stops along the horizontal mullion are butted to the vertical. A glazing gasket is used around the perimeter of the glazing unit, applied as one strip with a joint at the mid-point of the top of each unit. The joint is sealed with silicone.

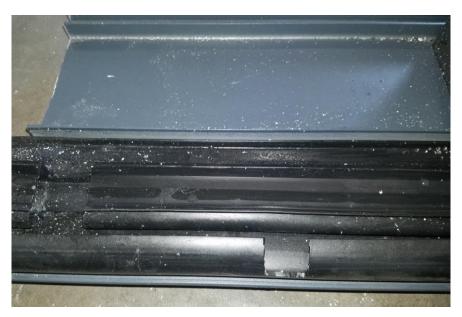
Drain slots cut into sill gaskets

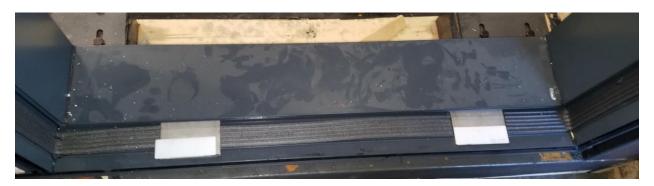
Setting blocks on aluminum carriers

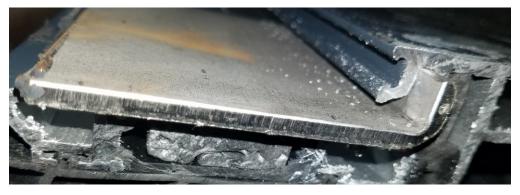
Aluminum setting block carrier
